Coastal processes schools case study: Porlock bay

Working for the South West Regional Coastal Monitoring Programme, the Plymouth Coastal Observatory measures and records detailed information on more than 2,000km of England's coastline from the Severn Estuary to Portland Bill

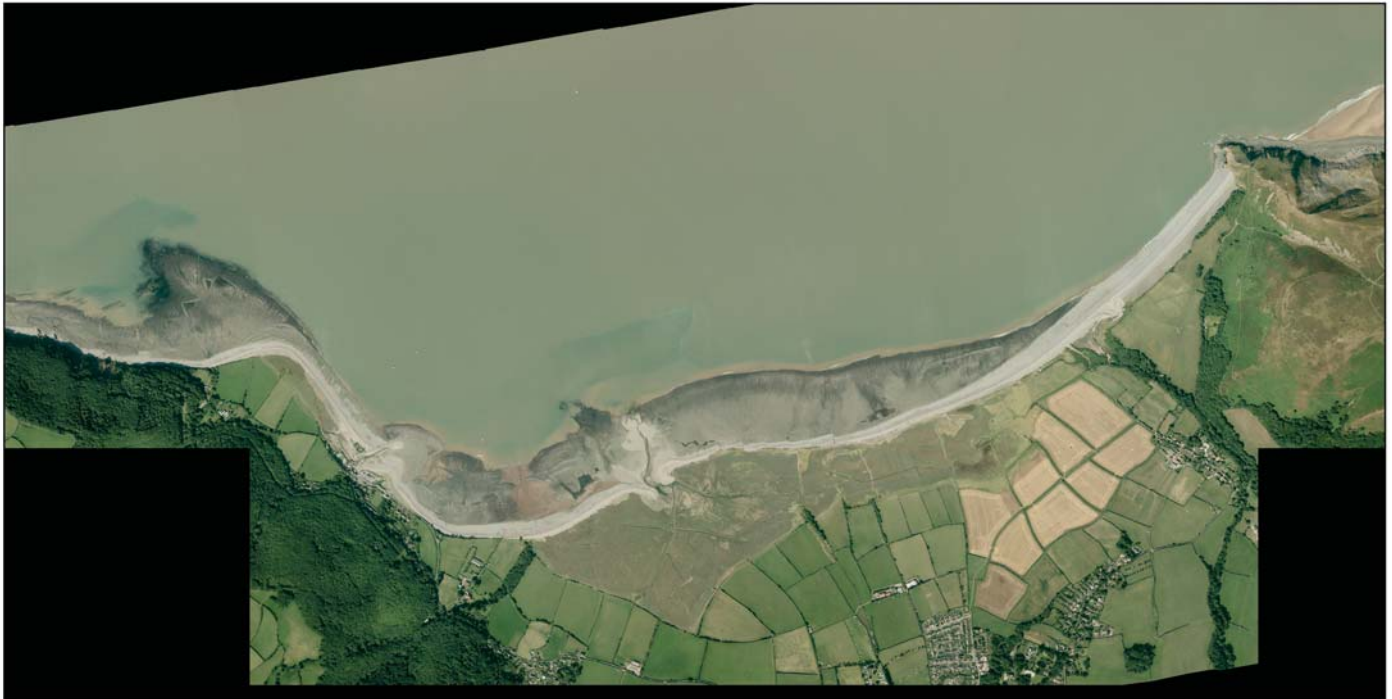
- 1 Porlock Bay is located on the coast of Somerset, facing north into the Bristol Channel. The beach here is made up of shingle which forms a long (5km), steep, barrier separating the sea from the low lying land behind. The beach has been built up and evolved over many thousands of years to its current shape. What do you think are the current dominant processes acting on the beach and what may be threatening the beach's current form?

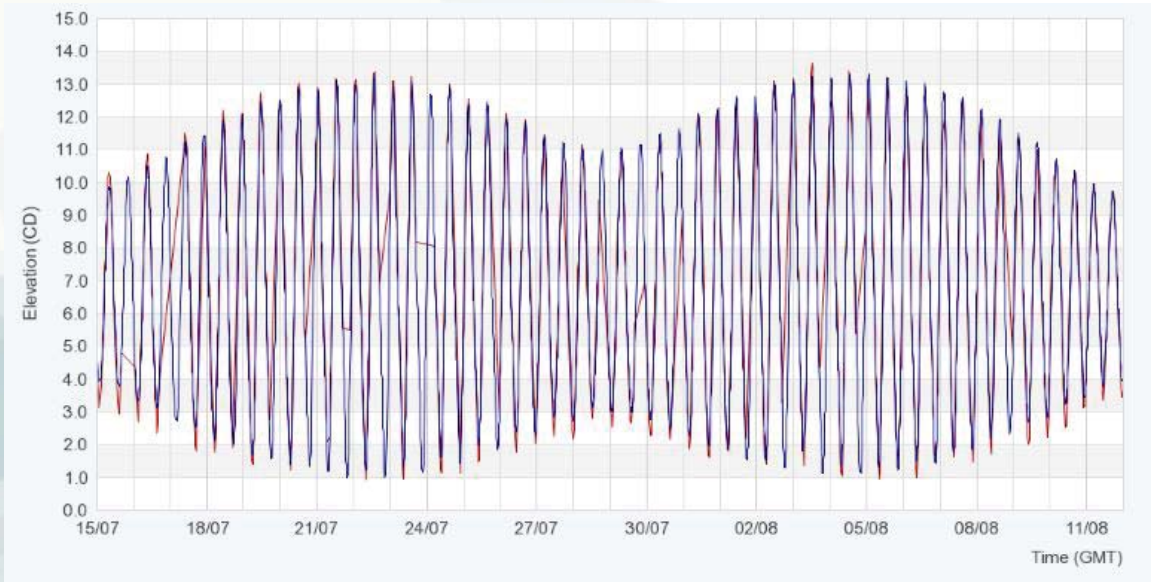
2 The Bristol Channel and Severn Estuary are known to have some of the largest tidal ranges in the world. Below is a tide chart from a tide gauge located on the Severn Bridge; from the chart below can you identify when the largest tide occurred and what the tidal range was on that day?

Being not so far into the estuary the tidal range at Porlock is slightly less at around 9m, although this is still very large. In this graph the blue line is a prediction of tide height and whilst red is the observed height by the tide gauge.

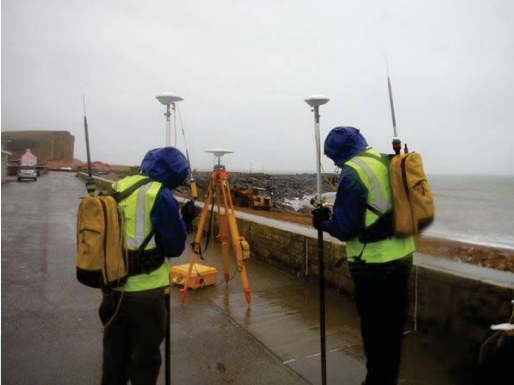
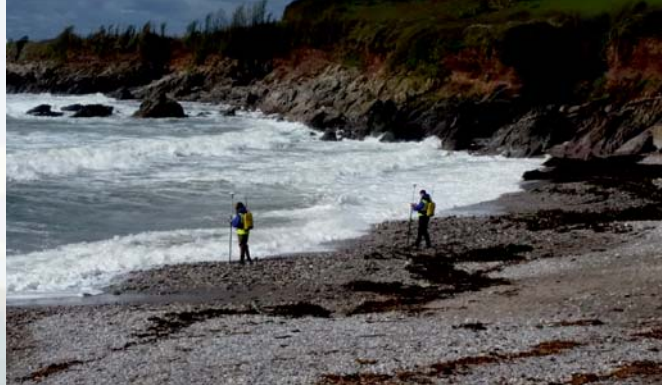
6 Since 2007 Plymouth Coastal Observatory have conducted regular surveys of Porlock Bay. Two surveys a year, in autumn and spring, have been conducted on foot to monitor the beach shape as well as LiDAR every few years and additional surveys after large storms. Can you think why it is important to collect this information and who will use it?

Surveying on foot is also important. The PCO team walk the same profiles from the top to the bottom of the beach on each visit (whatever the weather) so that comparisons can be made over time.

5 LiDAR (Light Detection and Ranging) is a mapping technique which uses lasers to measure the distance between an aircraft and ground surface. The aircraft flies at around 800m and sends light signals towards the ground; the distance to the ground is calculated by timing how long it takes for the light signal to bounce off the ground and return to the plane. Can you think why LiDAR is a good technique for surveying a beach such as Porlock and which other techniques could be used?

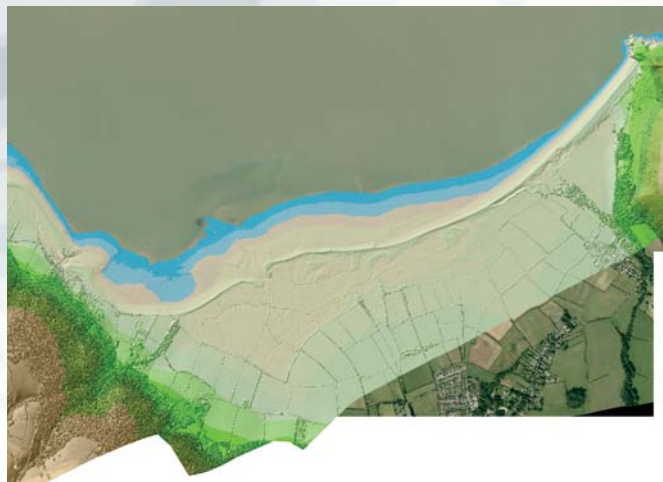
A LiDAR image of Porlock Bay. Blue is the lowest height and brown is the highest.

7 Since the 1996 breach, no effort has been made to restore the beach to its previous shape. Instead, the natural processes have been allowed to dominate and the land behind the beach now floods on a regular basis with the rise of the tide. What effect will this have on the land behind the beach and who will benefit from the changes?
