Coastal Processes

schools case study:

Berrow Dunes, Somerset

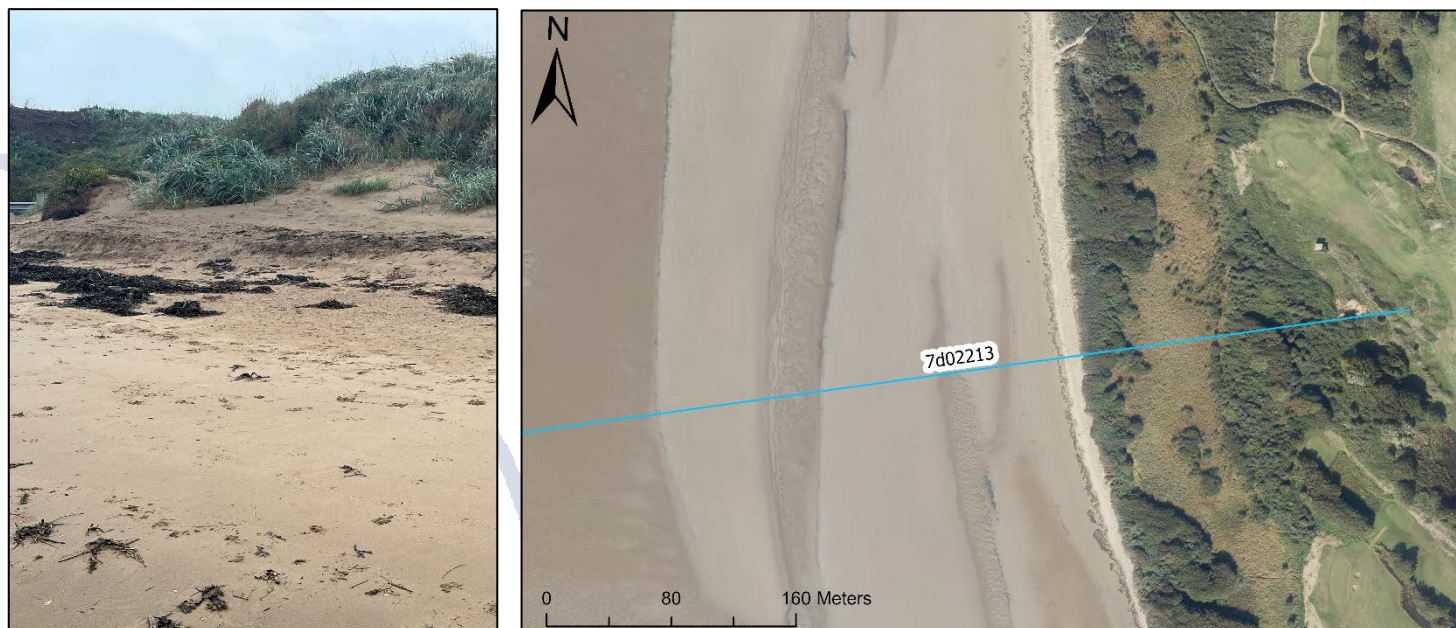
Figure 2 Left - a photo of Berrow Dunes from the 2023 autumn interim, taken by AGS Surveys 2023. Right - zoomed in aerial imagery (2018) indicating the location of profile 7d02213.

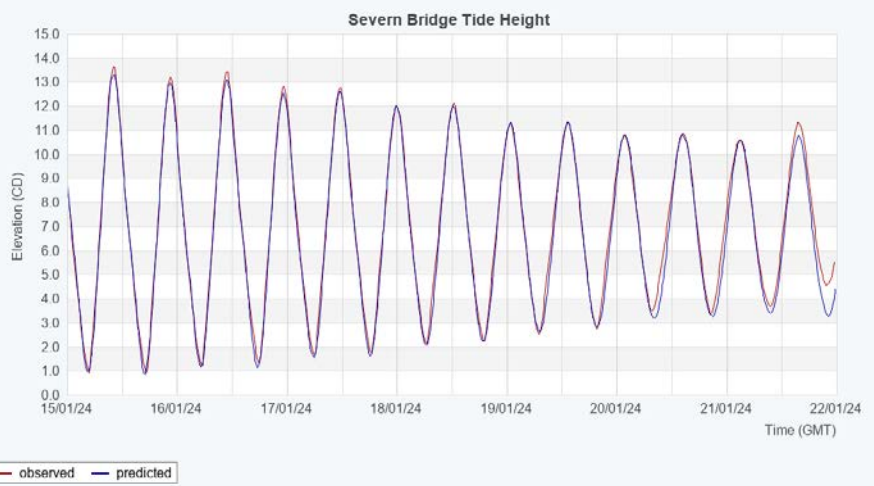
Figure 3 Top - daily tidal range, 13th January 2024 (GMT), at the Second Severn Crossing (SSC). Bottom - weekly tidal range, between 15th and the 22nd January 2024 (GMT), for the SSC. Predicted measurements are in blue and observed measurements are in red.

2 Have a look at the graphs and information from the tide gauge (Fig. 3) and see if you can work out the tidal range on the 13th January, 2024.

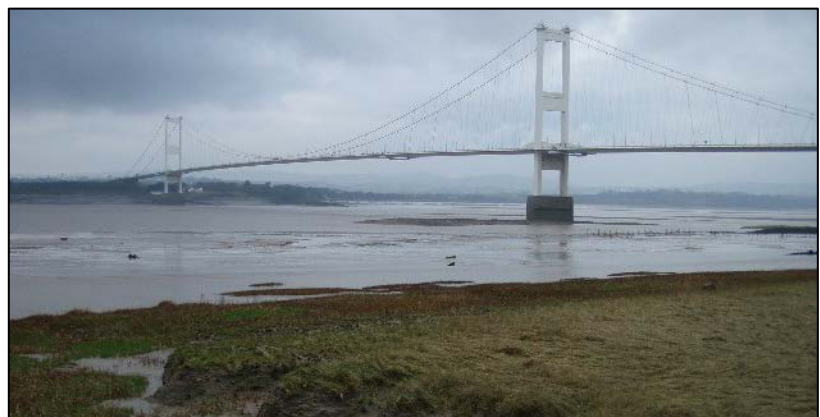
Figure 4 The Second Severn Crossing, where a Rosemount WaveRadar REX is installed to collect wave and tidal parameters.

SWCM has a tide gauge at the Second Severn Crossing (Fig.4) which broadcasts tide levels and wave heights directly to the website coastalmonitoring.org/realtimedata.

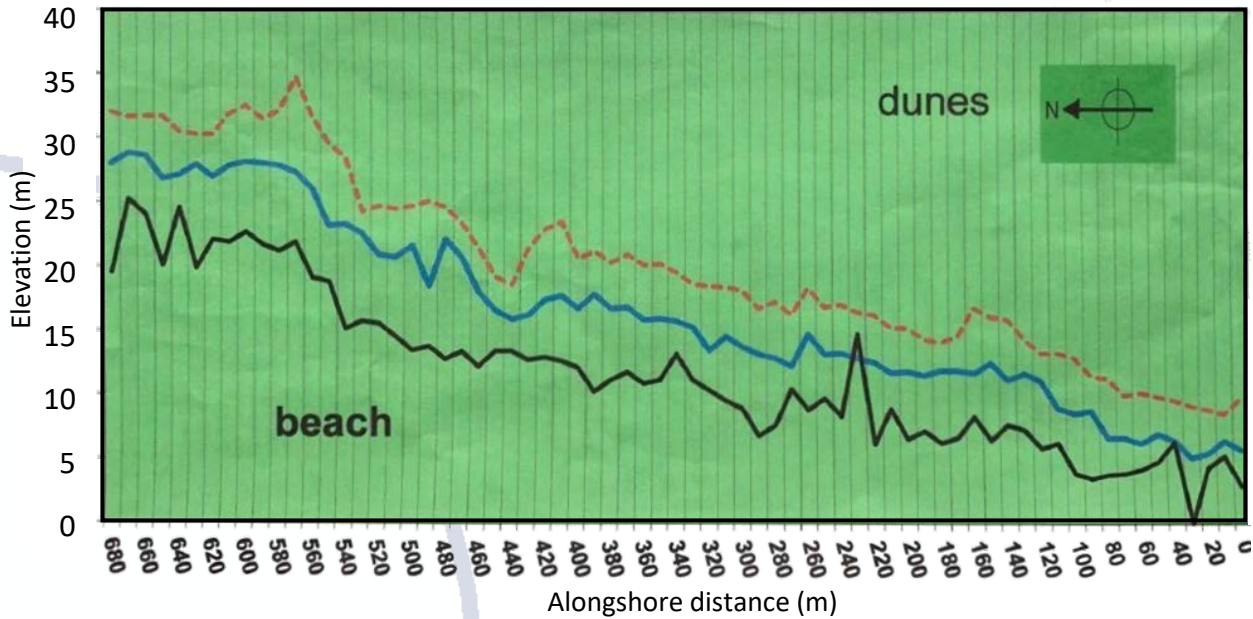
Figure 5 This graph shows the original data recorded in September 2009 (black line), October 2019 (blue line) and the latest survey in March 2020 (red dashed line). Carried out by the Berrow Conservation Group.

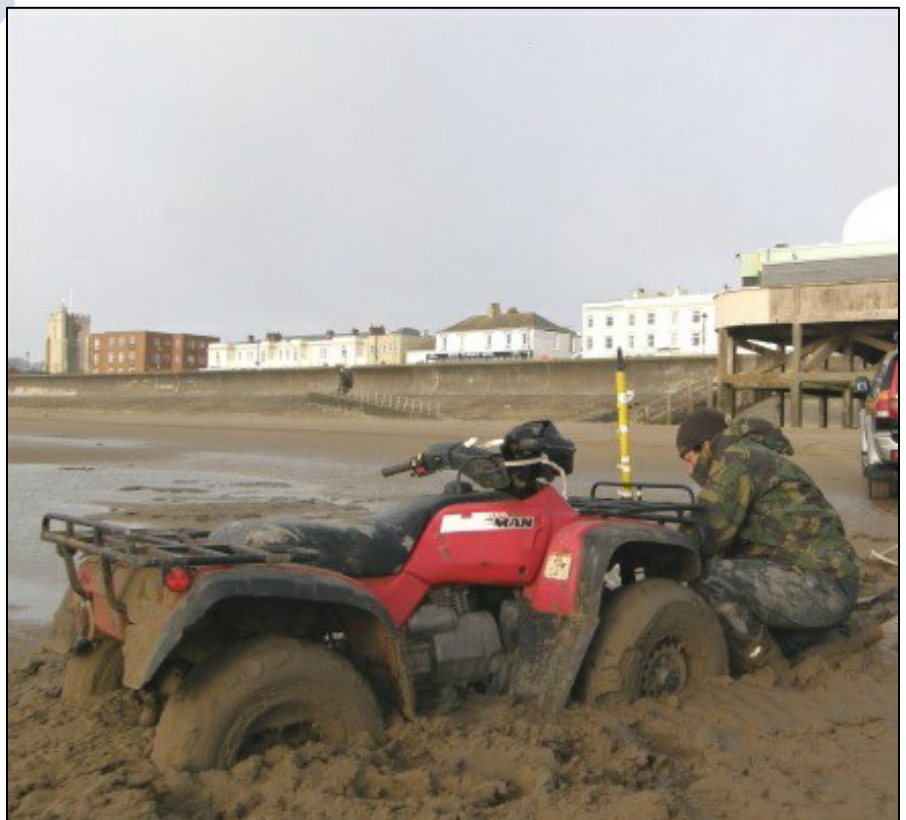
Figure 6 Surveyor and quad bike stuck in the mud at Burnham-on-Sea.

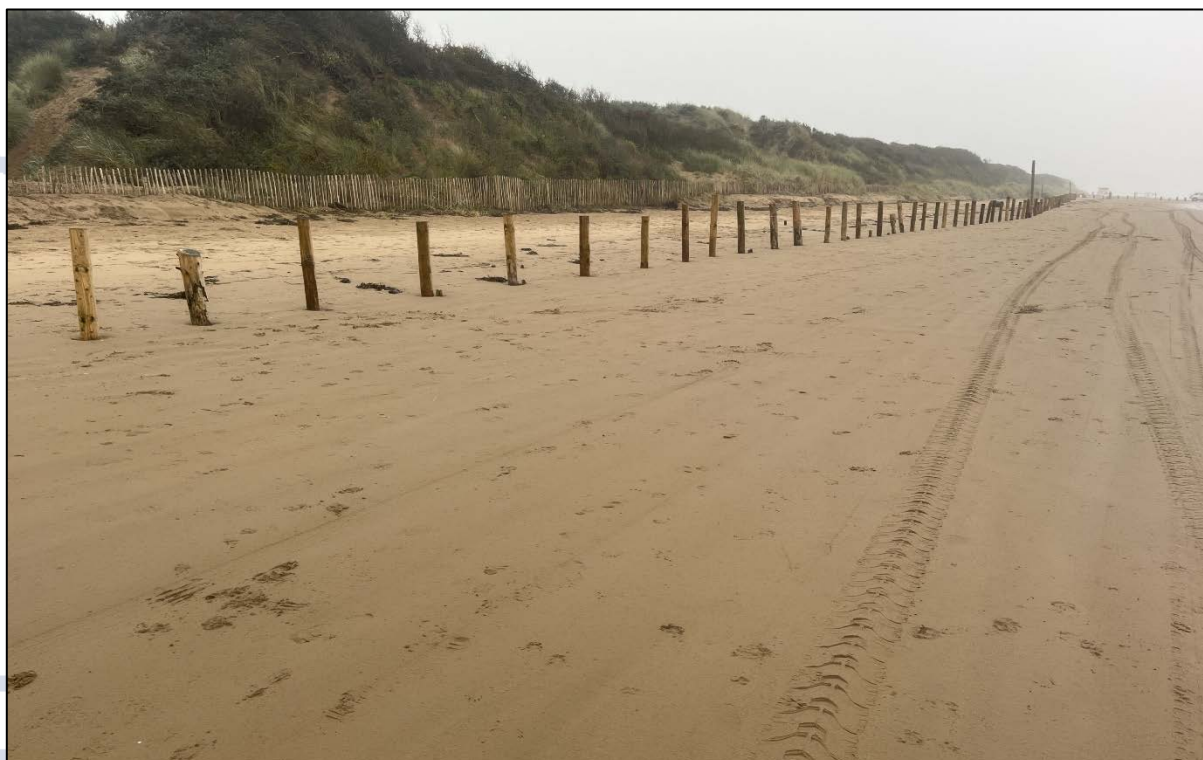
Figure 7 The northern end of Berrow dunes with wooden posts installed. Photo taken by AGS Surveys, 2023.

7 There is a line of posts, some of which can be seen in the photograph above (Figure 7), along the back of the beach, installed to stop the cars which are allowed to drive onto the beach harming the dunes. Can you think of a way you could use these posts to tell whether the dunes along this stretch of beach are eroding or accreting?

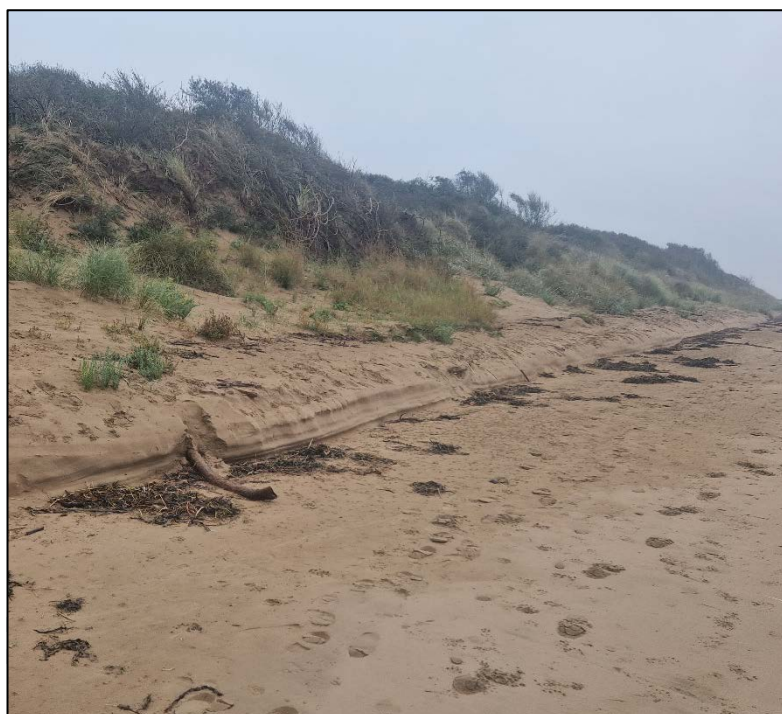
Figure 6 The dune section at profile 7d02234, Berrow Dunes. Photo taken by AGS Surveys, 2023.

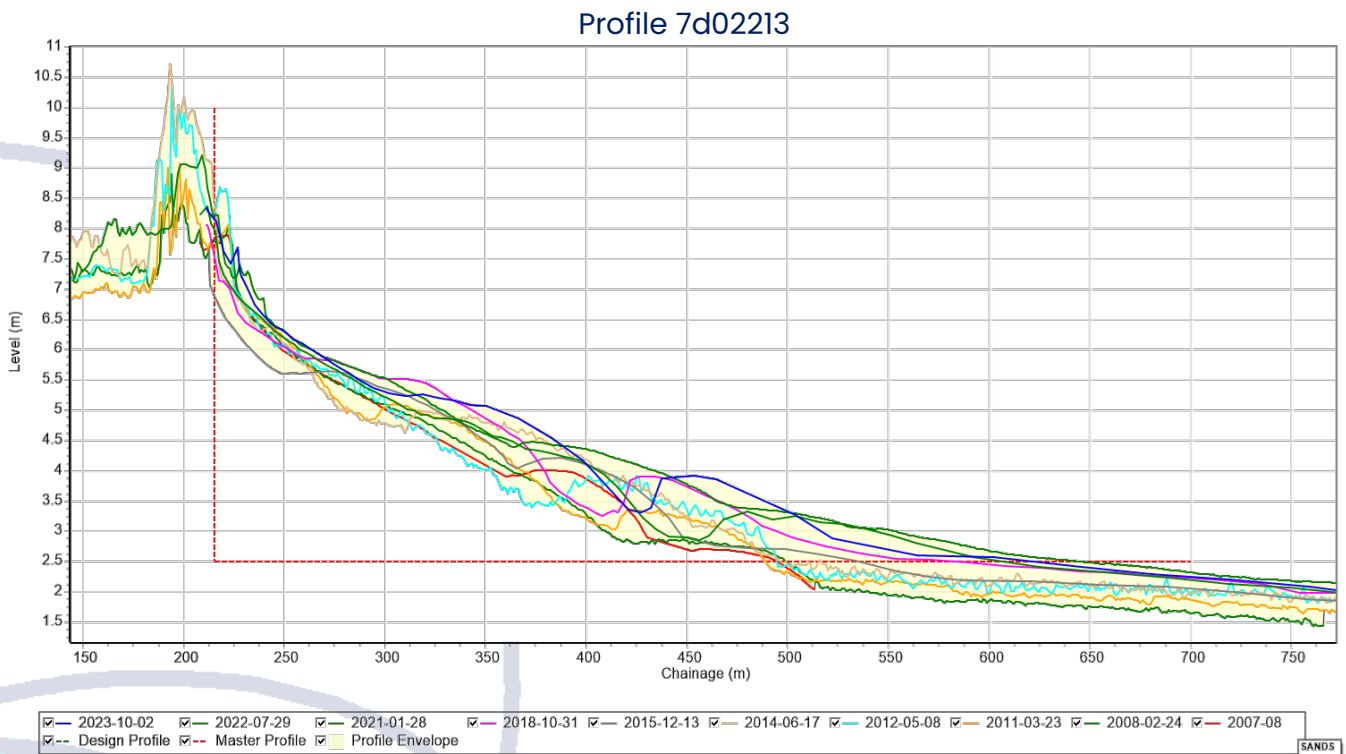
Figure 7 A side on graph depicting profile 7d02213 between the years 2007 and 2023.

9A The graph above (Figure 9) shows the beach profiles for profile 7d02213, looking at the years 2007, 2008, 2011, 2012, 2014, 2015, 2018, 2021, 2022, and 2023 measurements at Berrow Dunes. Look at the graph above, on the x-axis where the chainage reads 350 m. How much did the level of the beach rise or fall here, between 2012 and 2023?

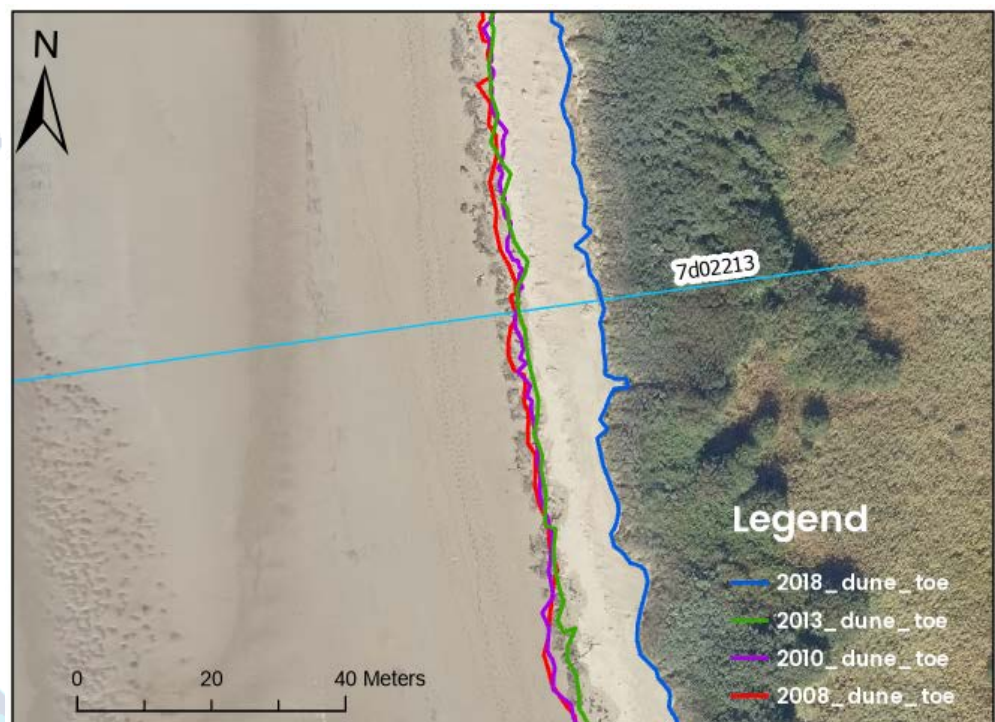
Figure 8 An aerial image, from 2018, of Berrow Dunes showing the dune toe for 2008 (red line), 2010 (purple line), 2013 (green line), and 2018 (blue line).

B The image on the right shows the same profile captured by aerial photography showing the position of the dunes in the years 2008, 2010 2013, and 2018. From the aerial image, can you say what has happened to the dunes at this point?
