Explanatory notes

South West Coastal Monitoring (SWCM) is the data-gathering arm of the Nation Network of Regional Coastal Monitoring Programmes (NNRCMP), which was founded in 2006 to provide a standard, repeatable and cost effective method of monitoring the coastal environment in the region.

Porlock Bay lies on the Somerset coast, facing northwest into the Bristol Channel. As such it experiences a large tidal range (~9 m) as well as storms which penetrate up the channel from the Atlantic. The beach itself is predominantly comprised of a long, steep shingle barrier formed over many thousands of years, moving landwards as sea level increased after the last ice age (and still showing signs of movement). The upper shingle section of the beach is steep due to the impact of storms waves which remove smaller material from the bottom of the beach. The beach provides important protection for the low-lying land behind.

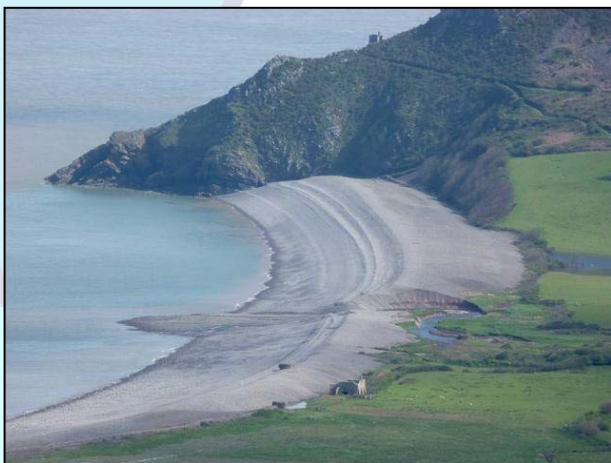
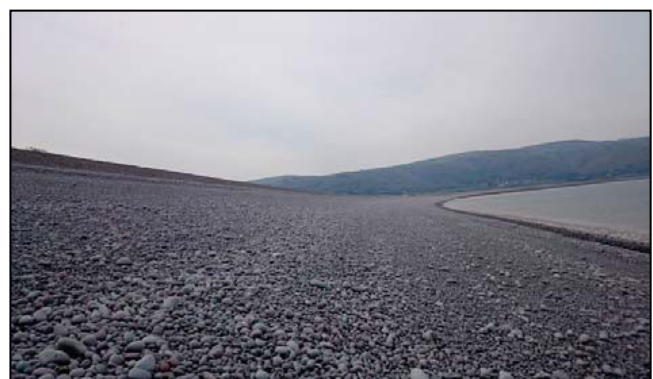
Figure 2 Photography of Porlock beach, depicting the barrier beach.

1 Porlock Bay is located on the coast of Somerset, facing north into the Bristol Channel. The beach here is made up of shingle which forms a long (5 km), steep, barrier separating the sea from the low-lying land behind (Figure 2). The beach has been built up and evolved over many thousands of years to its current shape. What do you think are the current dominant processes acting on the beach and what may be threatening the beach's current form?

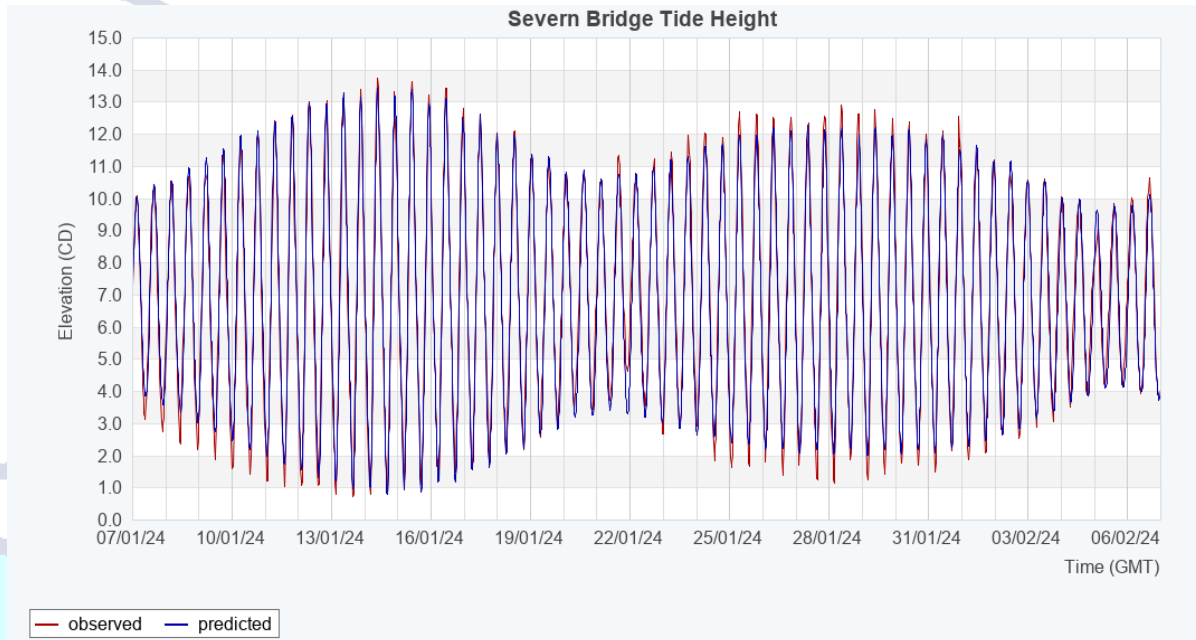
Figure 3 Tidal data for the Severn Estuary gauge between 7th January and the 6th February 2024.

Being not so far into the estuary the tidal range at Porlock is slightly less at around 9 m, although this is still very large. In this graph the blue line is a prediction of tide height, whilst red is the observed height by the tide gauge.

2 The Bristol Channel and Severn Estuary are known to have some of the largest tidal ranges in the world. Below is a tide chart from a tide gauge located on the Severn Bridge; from the chart below (Figure 3) can you identify when the largest tide occurred and what the tidal range was on that day?

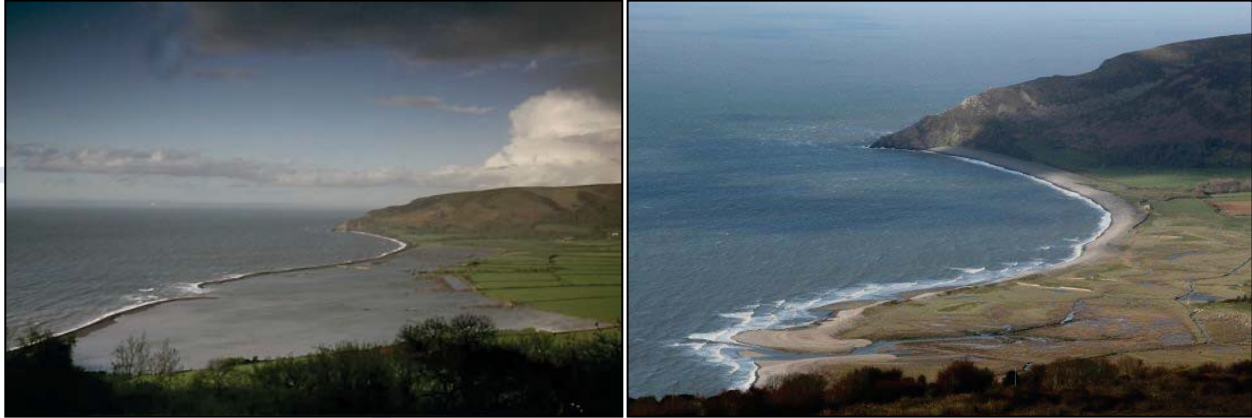
Figure 5 Photography of Porlock when flooded (left) and at low tide (right).

3 In October 1996 a severe storm surge coincided with a high tide to elevate water levels to an extreme height. The top of the beach was pushed backwards and destroyed allowing seawater to flood the low-lying land behind. As the tide

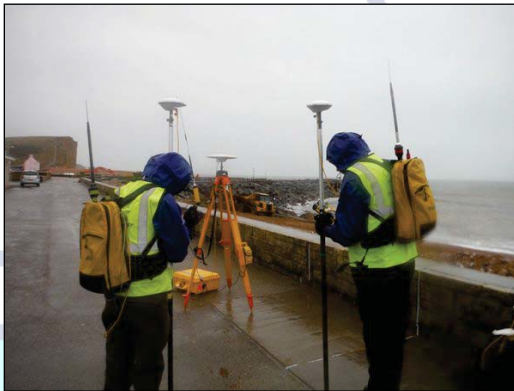
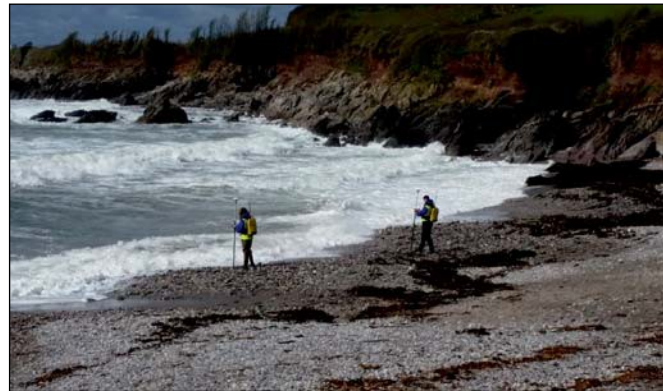
Surveying on foot is also important. The SWCM team walk the same profiles from the top to the bottom of the beach on each visit (whatever the weather) so that comparisons can be made over time.

Figure 4 The SWCM team surveying Porlock.

6 Since 2007 South West Coastal Monitoring have conducted regular surveys of Porlock Bay. Two surveys a year, in autumn and spring, have been conducted on foot to monitor the beach shape as well as LiDAR every few years and additional surveys after large storms. Can you think why it is important to collect this information and who will use it?

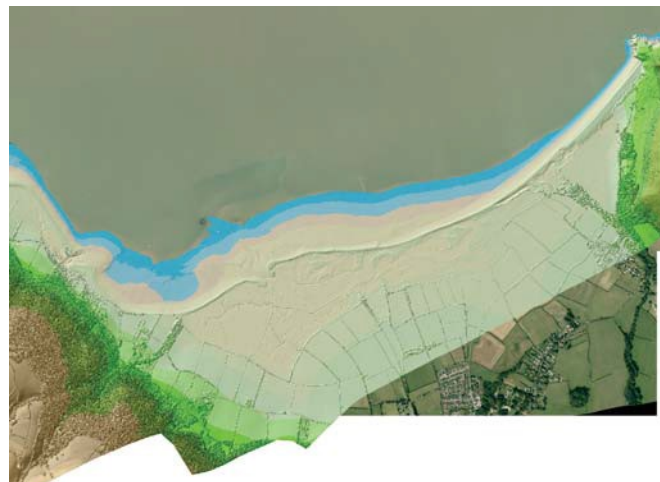
Figure 3 A LIDAR image of Porlock Bay. Blue is the lowest height and brown is the highest.

5 LiDAR (Light Detection and Ranging) is a mapping technique which uses lasers to measure the distance between an aircraft and ground surface. The aircraft flies at around 800m and sends light signals towards the ground; the distance to the ground is calculated by timing how long it takes for the light signal to bounce off the ground and return to the plane. Can you think why LiDAR is a good technique for surveying a beach such as Porlock and which other techniques could be used?
