Explanatory notes

But at Seaton, near Looe in Cornwall, an extra factor came into play: data gathered by the scientists at the South West Coastal Monitoring shows how a river came to weaken a seawall, helping to lead to its collapse.

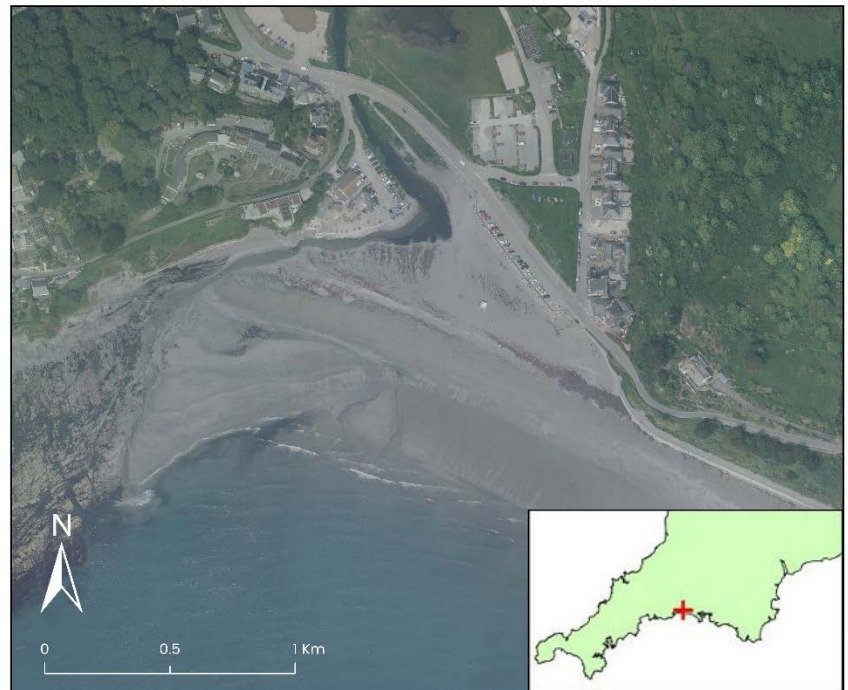
Figure 1 An aerial photo of Seaton, Cornwall (2018).

Look at the aerial photograph of the beach on the right (Figure 1) – What feature is present which may have had a big impact on the movement of material on the beach?

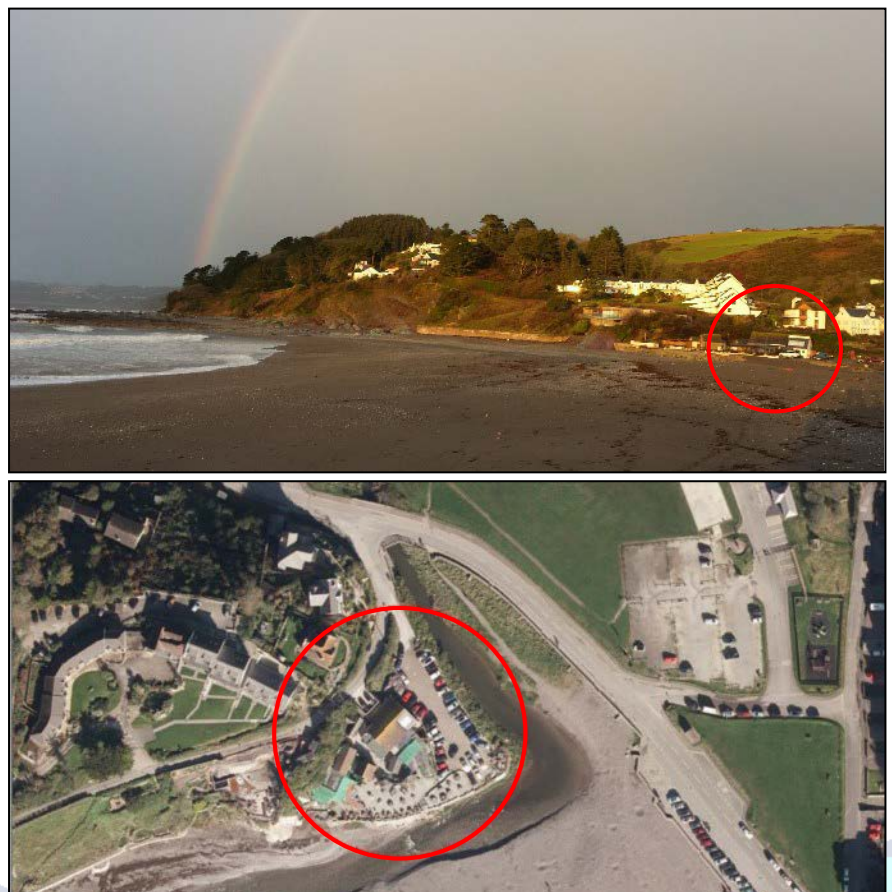
There is a café behind the beach which can be seen highlighted in the photographs on the right. Do you think the shape of the beach can have an impact on how storms and storm waves affect the café?

Figure 4 The top image shows a side on image of the café, whilst the bottom photo depicts an aerial image of the café at Seaton.

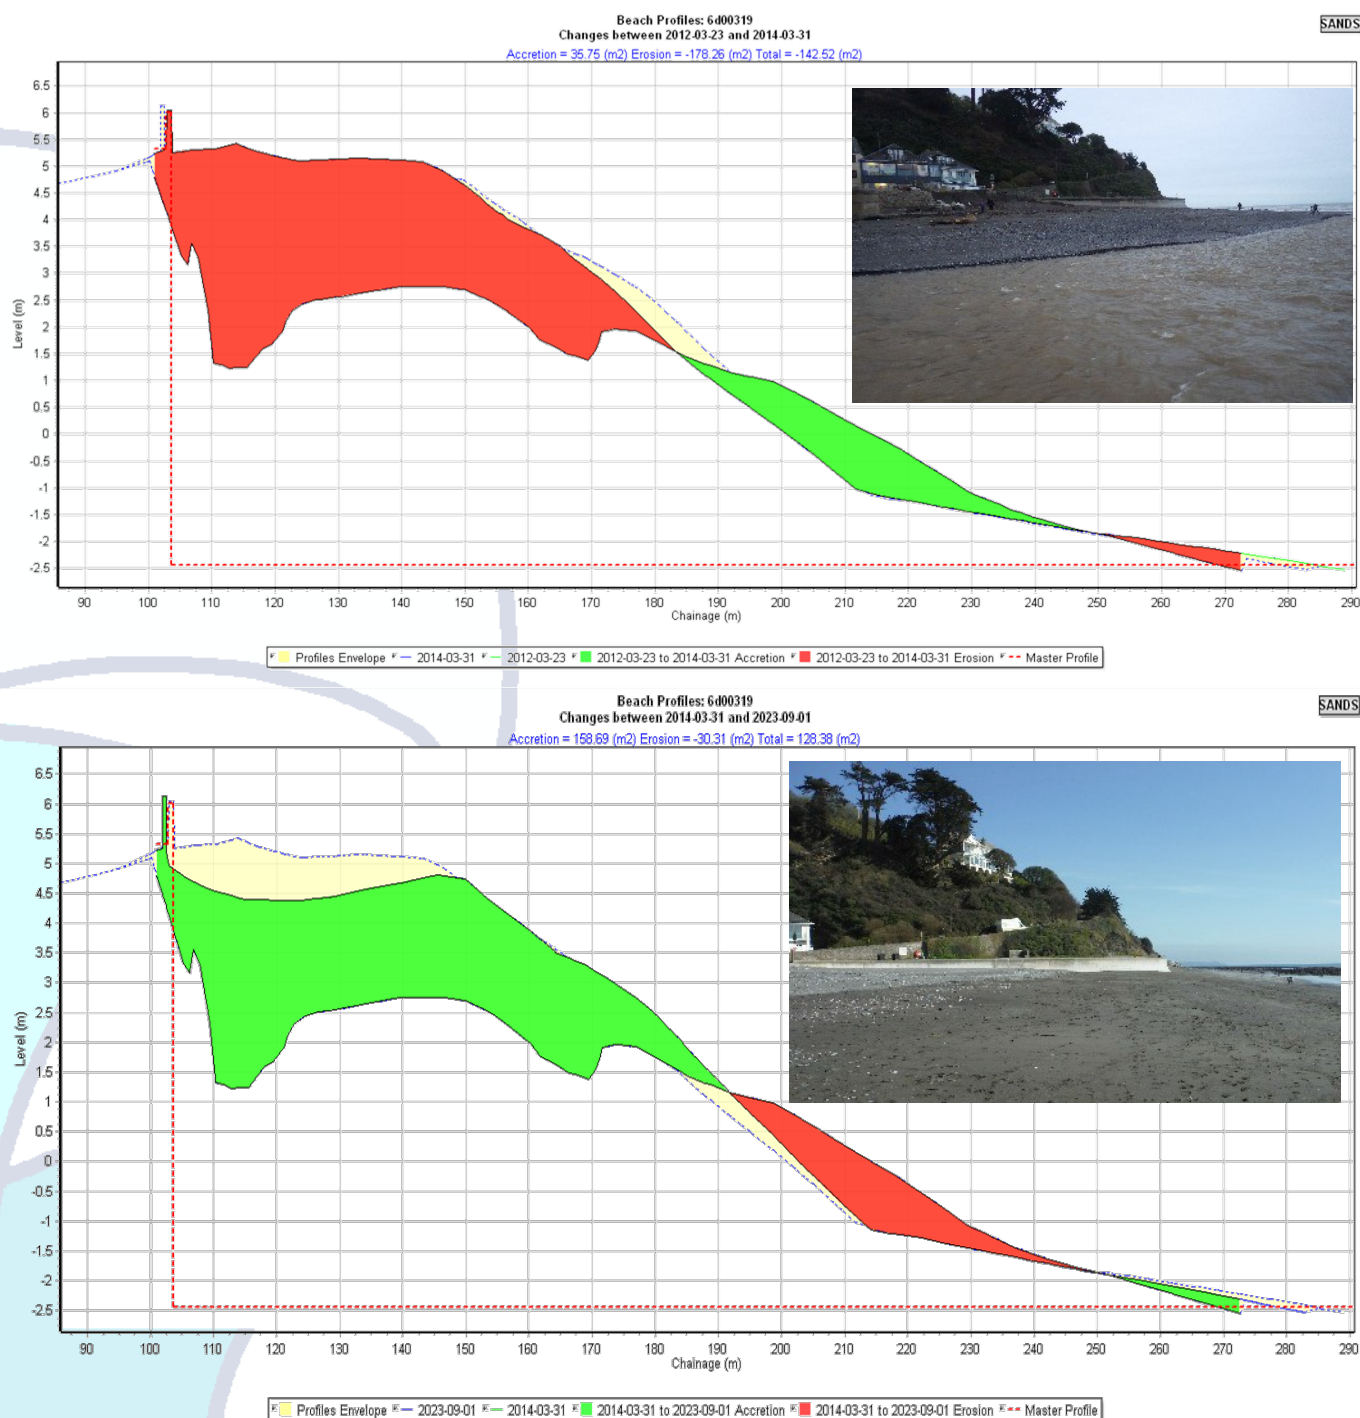
Figure 5 Profile 6d00319, top: sediment change between 2012 and 2014. Bottom: sediment change between 2014 and 2023. Green represents accretion whilst red represents erosion.

4 Take a look at these two beach profiles made by the coastal processes scientists at South West Coastal Monitoring. The top one shows changes to the beach between March 2012 and January 2014. The red area shows erosion, the green area shows accretion. The lower one shows the changes between January 2014 and September 2023. The inset photographs were taken along the profiles. There were severe winter storms in late 2013, early 2014. What was happening to the beach in the years before the storms, and what impact do you think the storms had on the beach?

Since those storms, new defences have been built and beach reprofiling has taken place, returning it to its pre-storm condition, as can be seen when beach profiles taken by the SWCM at various times are compared.
