## Explanatory notes

South West Coastal Monitoring (SWCM) is the data-gathering arm of the South West Regional Coastal Monitoring Programme, which was founded in 2006 to provide a standard, repeatable and cost effective method of monitoring the coastal environment in the region.

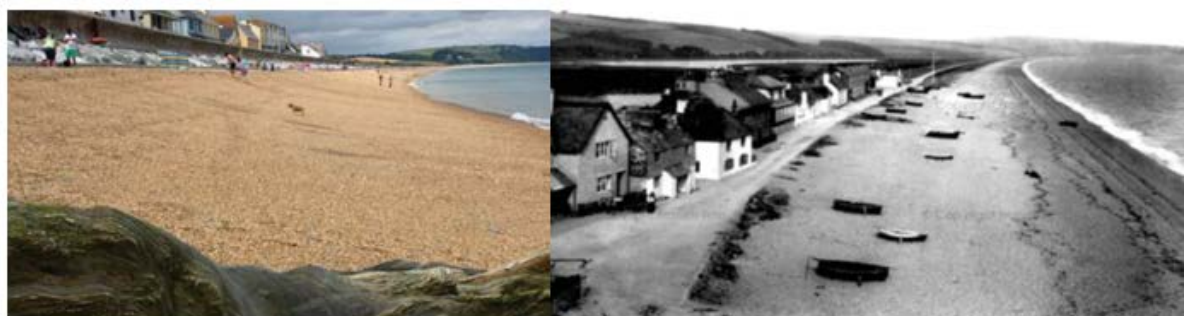
Figure 6 Right Southern end of Slapton Sands 2024. Left 1907

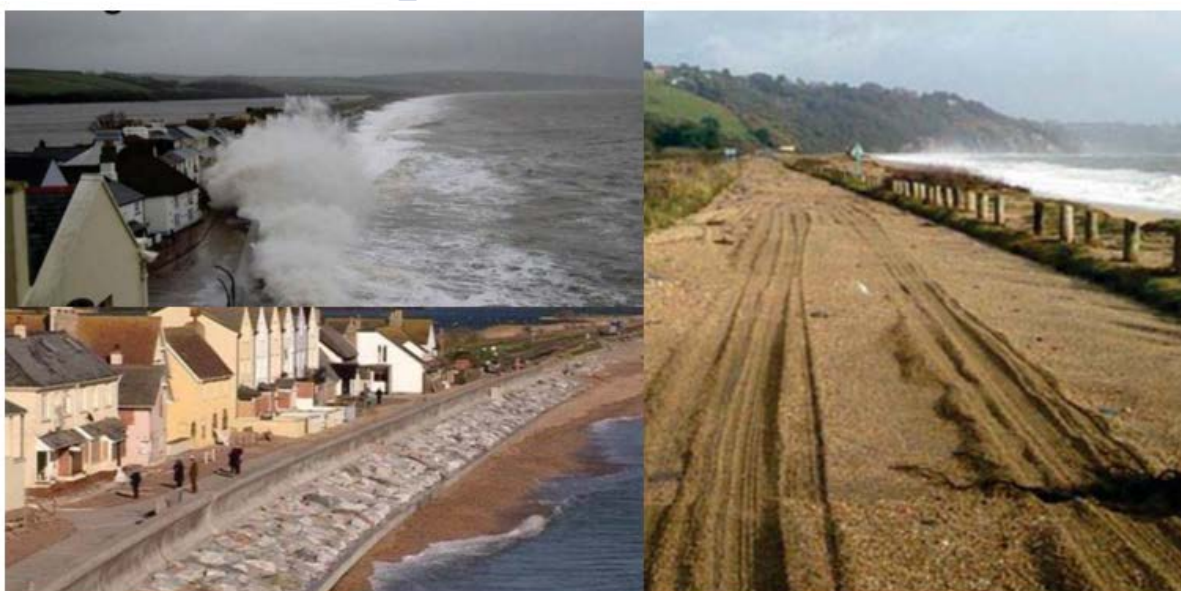
**5** The images shown in Figure 7 (below) show some of the impacts of the storms which happened in the winter of 2013 and Spring of 2014. Notice how the bottom of the seawall in front of Torcross in the south is uncovered, whilst at the northern end the road is covered with shingle. The wave rose in Figure 8 shows the storm wave conditions, from February 2014 storm events. Compare the wave rose in Figure 8 to the previous one shown in Figure 2, which shows the average wave conditions. How do the wave heights differ and what direction were the predominant storm waves?

*Figure 7 2013/2014 Storm events. Waves crashing over the sea defence, uncovering of the bottom of the sea defence at the souther end of Slapton Sands and the road at the northern end covered in shingle*
