# Coastal Processes

## schools case study:

### Sidmouth, South Devon

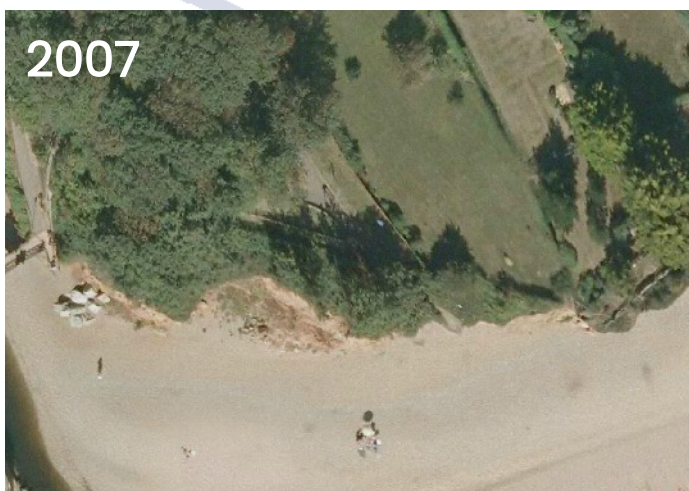
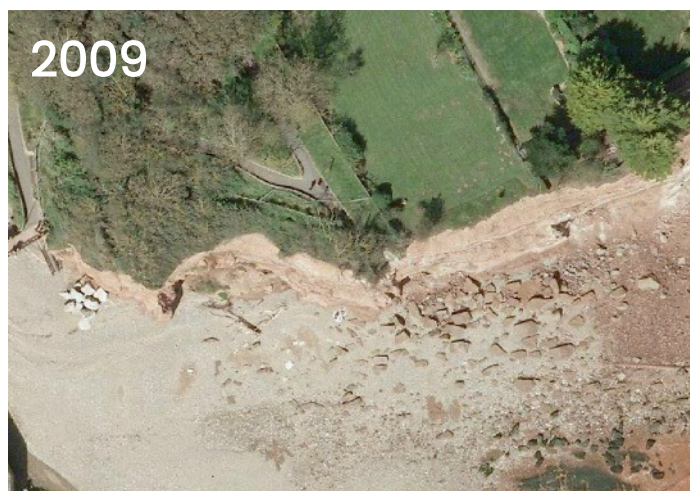
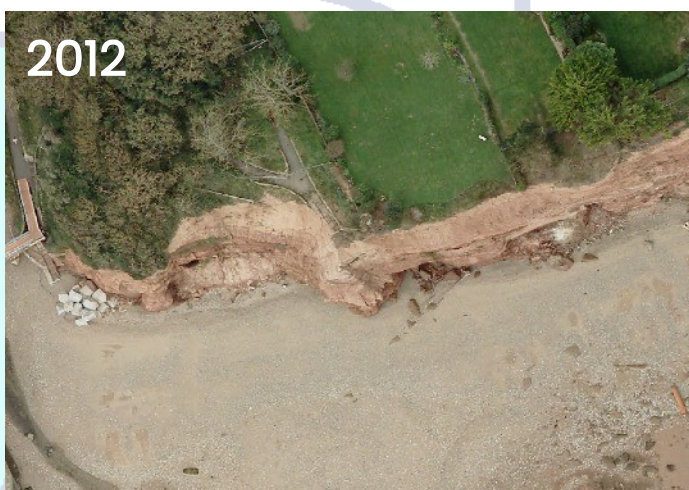
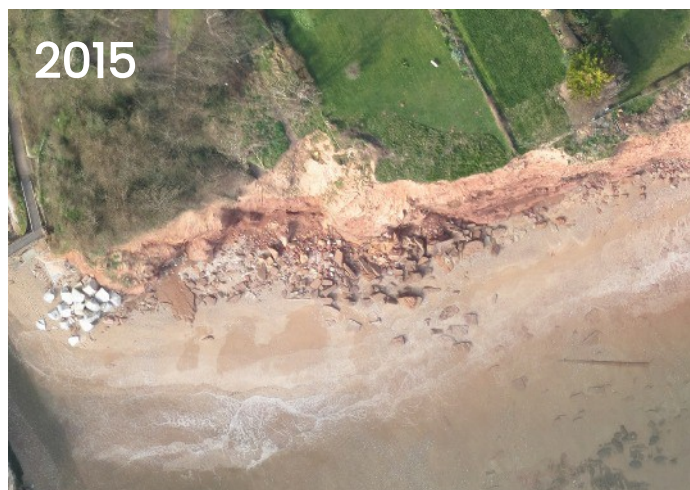
Figure 1 Aerial imagery of Sidmouth displaying cliff erosion lines, from the years 2007, 2009, 2012, and 2015.

The images on this page and the next were taken by the SWCM as part of their monitoring, and show the cliffs at Pennington Point.

"The data that we have collected highlights some of the contributing factors to the cliff failure at Pennington, with a good correlation between the erosion of the beach, at the toe of the cliff, and increased activity on the cliff face."

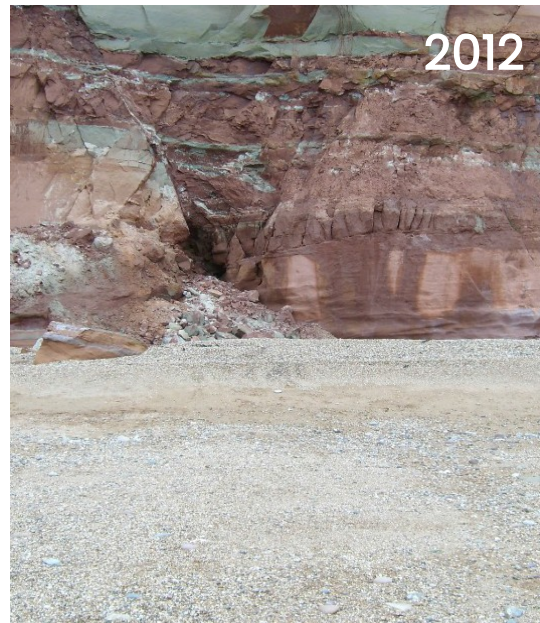
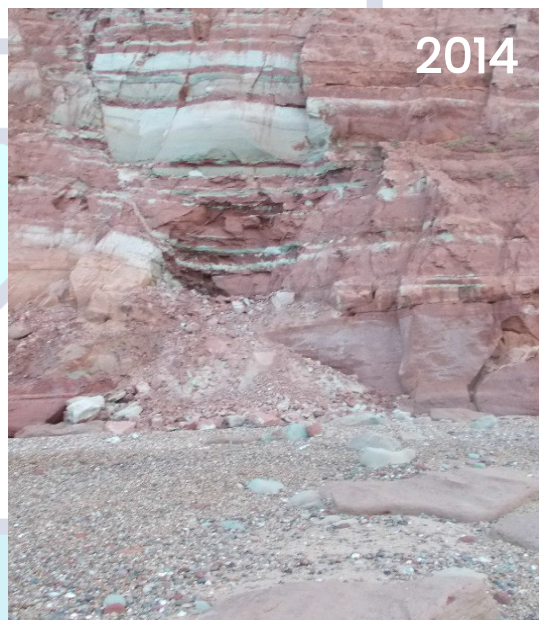
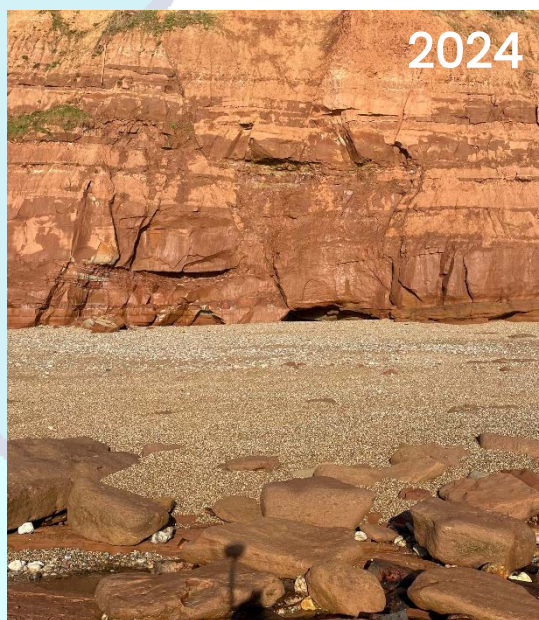
Figure 2 Side on imagery of Sidmouth cliff erosion from years 2007, 2012, 2014, 2015, and 2024.

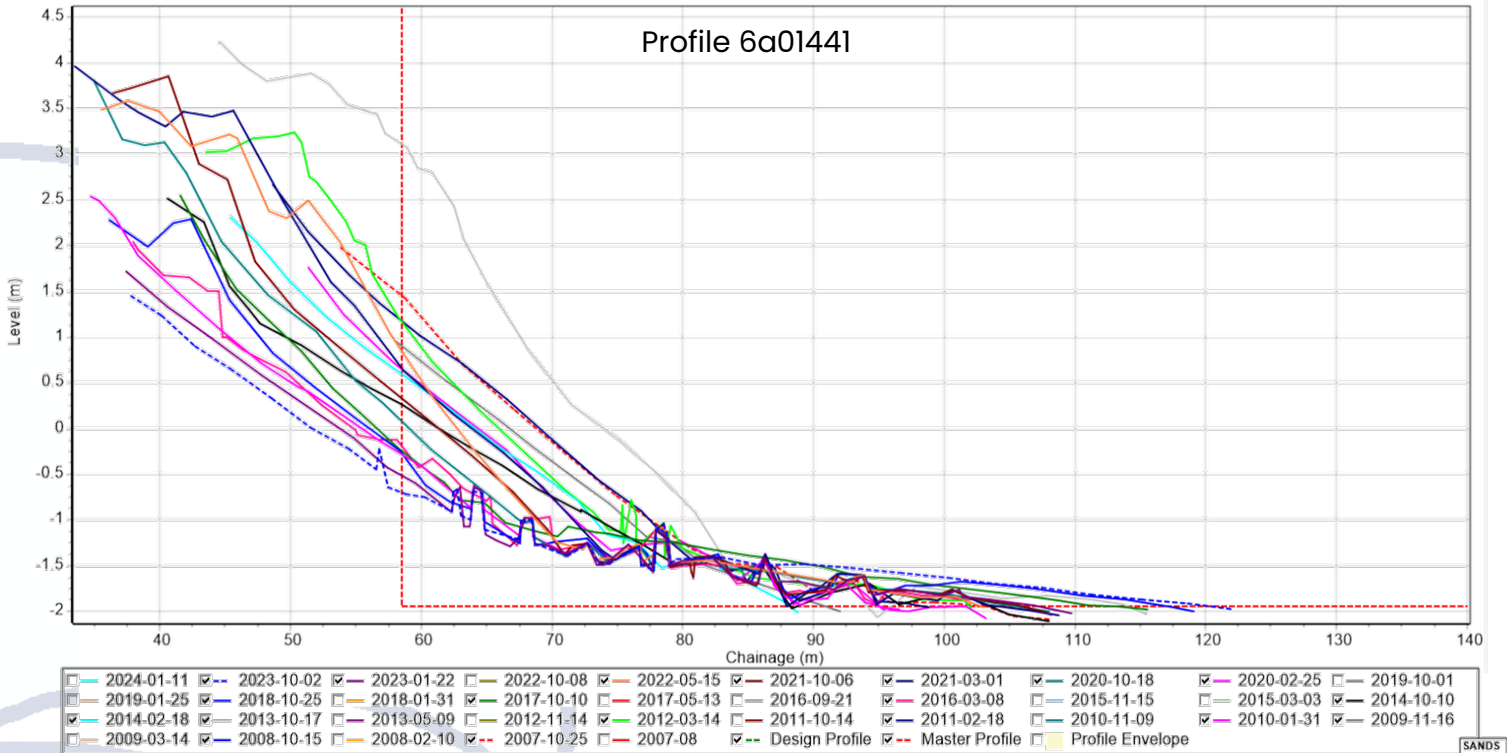
Figure 5 Side on view of profile 6a01441 displaying topographic profiles between the years 2007 and 2024.

The coast is divided into segments, so accurate measurements can be made from the same points time and again. This produces graphs called beach profiles, which again can then be used to show the changes taking place. Comparing profiles taken at Pennington Point at Sidmouth shows that the levels of the beach there have fallen in some places by more than a meter – since 2007. The data also shows what happened after a large rock fall in 2012.

7 At the top of the page is a graph showing changes to a beach profile from Pennington Point. The first profile is from 2007 (dashed line in red) and the latest is from October 2023 (dashed line in dark blue). The accompanying photos were taken on the same profile. Measuring from the master profile (broken red line) what has happened to the level of the beach between 2007 and 2023? Can you use the photographs to support your view?

8 What do you think happened between 2012 and 2013, where the beach appears to accrete dramatically? (Grey solid line) Where do you think this additional sediment came from?

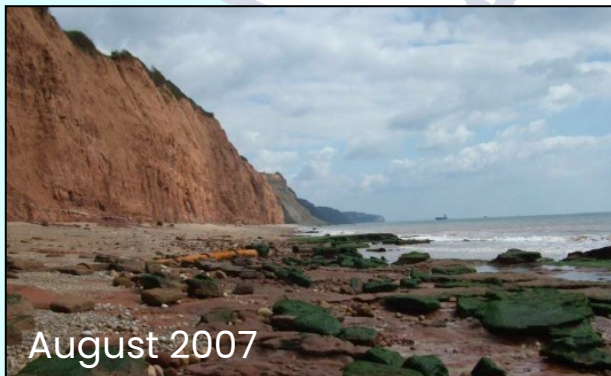
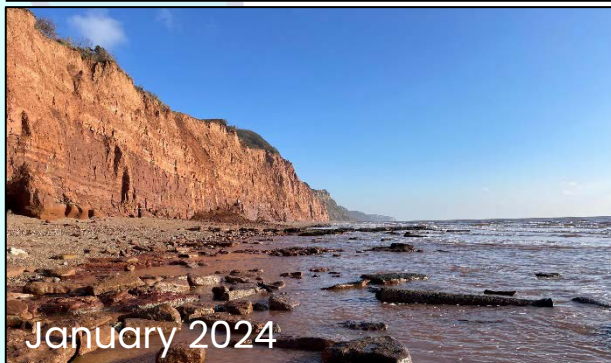
Figure 4 Photographs (to the left) of Sidmouth cliffs, looking east, from profile 6a01441. Taken by EDI surveys.
